Failure Analysis of Brake Panel on Automotive Braking System

Munaji^a, Yoyok Winardi^a,

Abstract

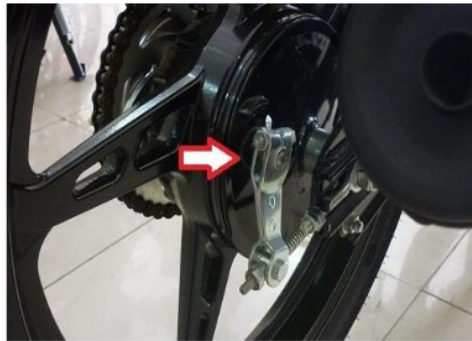
Methods used to determine the occurrence of failed component are macro and micro observation, chemical composition, and testing of mechanical properties (7). Failure analysis of braking panel system of motorcycle are presented. Figure 1 shows the brake system component of a motorcycle. Brake panel/backplate is a failed component. This component has been repaired. After used in 3 months, the brake panel is fractured during braking process. From the result of the observation using digital camera, the obtained shape and fracture location as shown in Figure 2.

Figure 1. Braking system

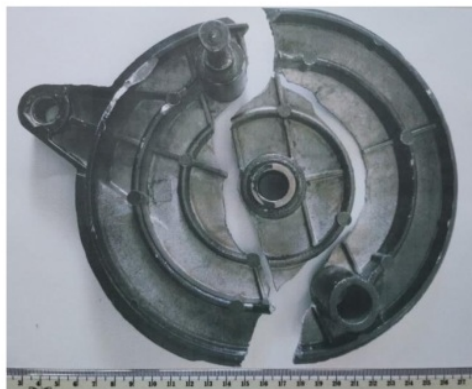
Figure 2. Broken component
